Wisconsin Barn Raising Project

Location: N9449 County Highway S (Chippewa County)

Constructed in 1904.

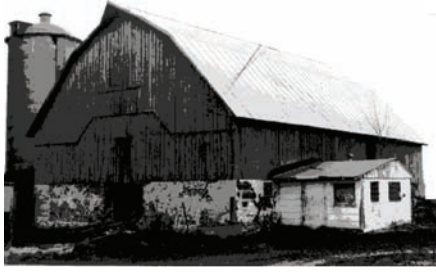
The barn is 40' wide 100' long and 40' tall. It was designed and built by a local craftsman named Andrew Mickelson. Mickelson's barns are many and distinguished by the pitch of their gambrel roofs, which then determines the proportion of the building. Each barn is identified by a five-pointed star located at the peak and each end of the building. Mickelson is reported to have said that the five-pointed star represented himself and his four sons all of whom worked with him.

The post and beam construction of the barn rises into three different levels, all above ground.

The bottom level, which housed the animals, is constructed of stone rubble, a cheap and readily available material. Its interior was cemented floors and gutters with a ladder opening to the above floor and shuts for throwing down hay.

The second level was accessed by massive sliding, external doors. Its plank floor was divided into three sections. The mid-section was where the wagons of hay were backed into and unloaded into the lofts on either side. The fork used to unload the cut hay and later bails is still in the roof peak.

Massive beams rise to support the roof which has two cupolas (windowed) for both light and air. Hay was stacked to the rafters for winter feeding.
